DISTINCTIVE LEARNERS EXCEPTIONAL LEADERS

FACILITY ASSESSMENT

BOYD ELEMENTARY SCHOOL

BOYD INTERMEDIATE/MIDDLE

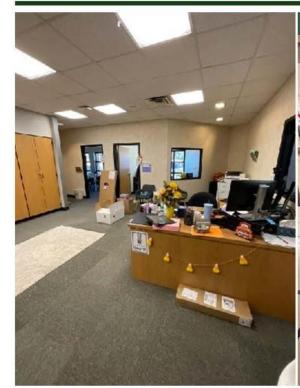
DOES NOT MEET TAS/ADA

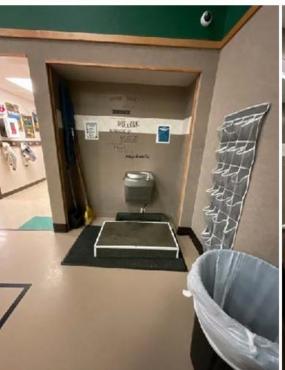
DOES NOT MEET TAS/ADA

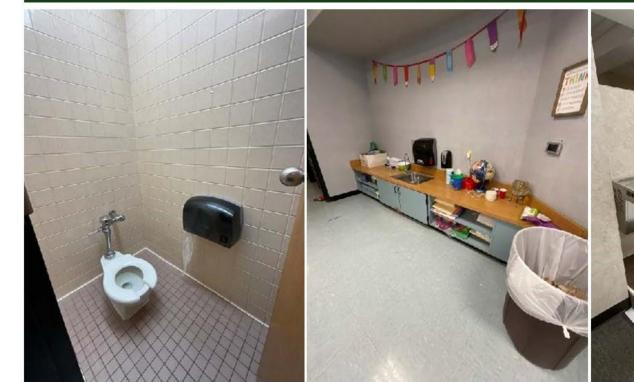
DOES NOT MEET TAS/ADA

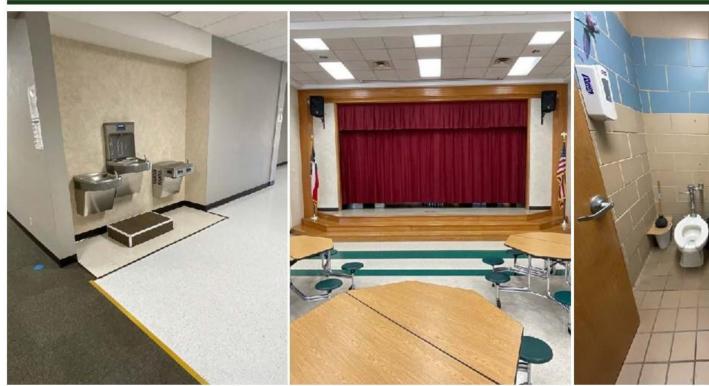
DOES NOT MEET TAS/ADA

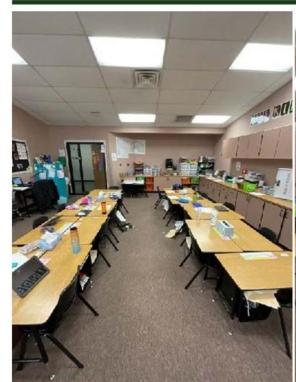
UNDERSIZED CLASSROOM

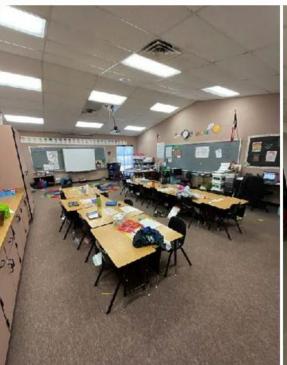
UNDERSIZED CLASSROOM

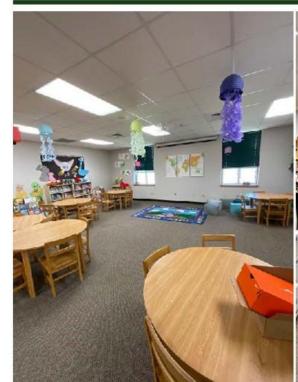
UNDERSIZED LIBRARY

DOES NOT MEET TAS/ADA

- Determine the maximum student population for an elementary campus for current and future buildings
- As student population grows, expand current facility or consider building a second elementary school
- Relocate current library into renovated space to meet current TEA standards and expand classroom wing for education spaces that would be displaced
- Upgrade and replace kitchen equipment that is not working i.e. disposal
- Replace carpet throughout entire building
- Repair perimeter fence gates that are not aligned to improve security
- Install panic release hardware on exterior exit gates
- Repair roof leaks and address clogged condensate lines
- Replace any water damage ceiling tile due to storm water or leaks from a condensate line or plumbing
- Protect existing parking lot lights from damage by installing a concrete island with curbs

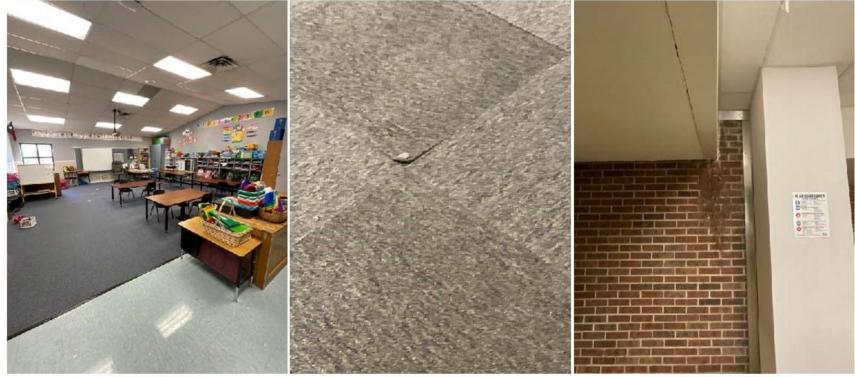
AGING FINISHES AGING FINISHES EVIDENCE OF MOISTURE

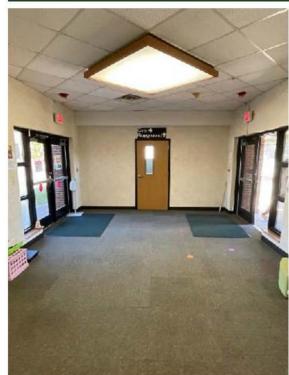
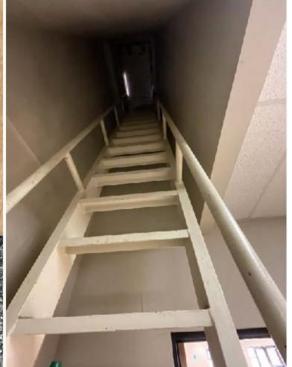
SECURITY RISK SAFETY RISK SECURITY RISK

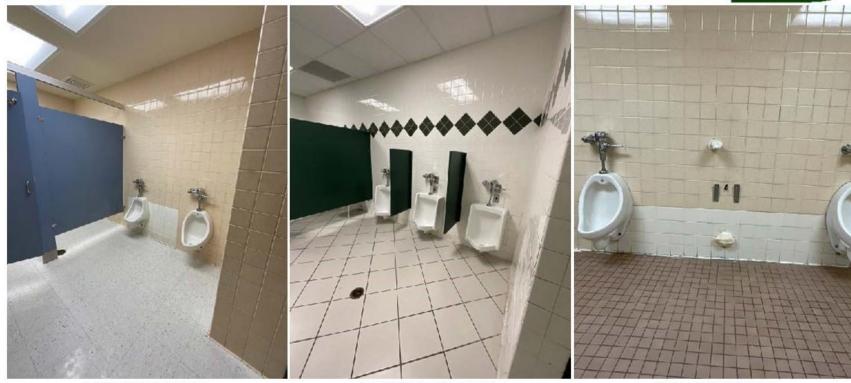
NEED HDPE DIVIDERS HDPE DIVIDERS PRESENT NEED HDPE DIVIDERS

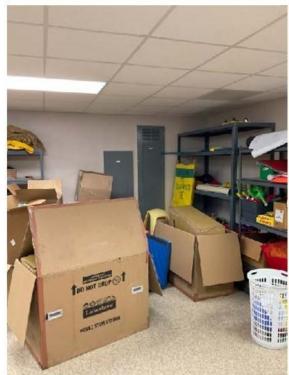
INADEQUATE STORAGE

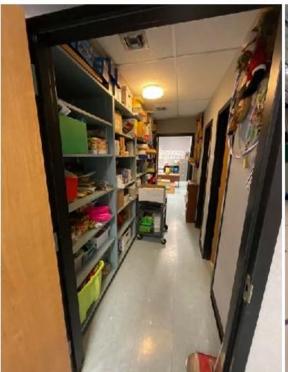
INADEQUATE STORAGE

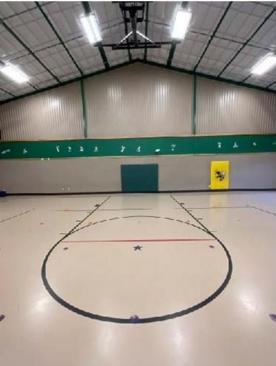
INADEQUATE LIGHTING

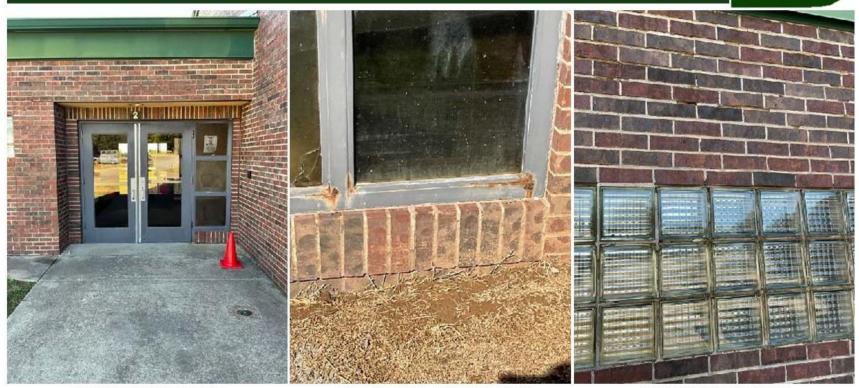
NEEDS SECURE VESTIBULE

DETERIORATING WINDOW FRAME

DETERIORATING MORTAR

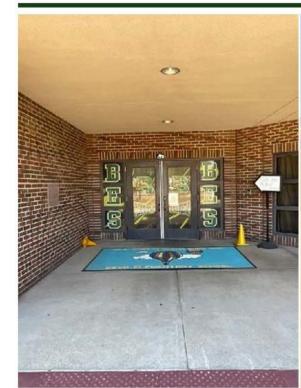
INADEQUARTE LIGHTING

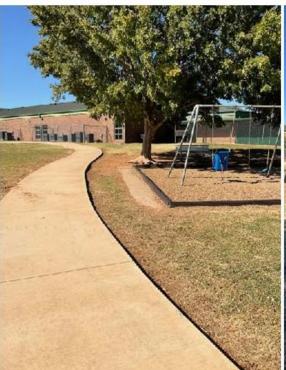
DOES NOT MEET TAS/ADA

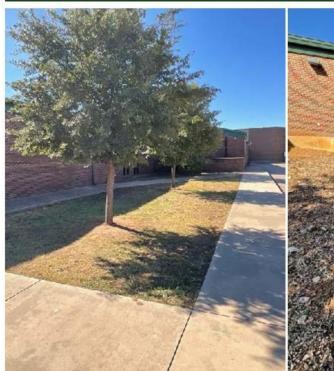
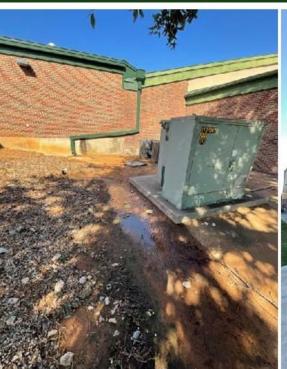
INADEQUARTE DRAINAGE

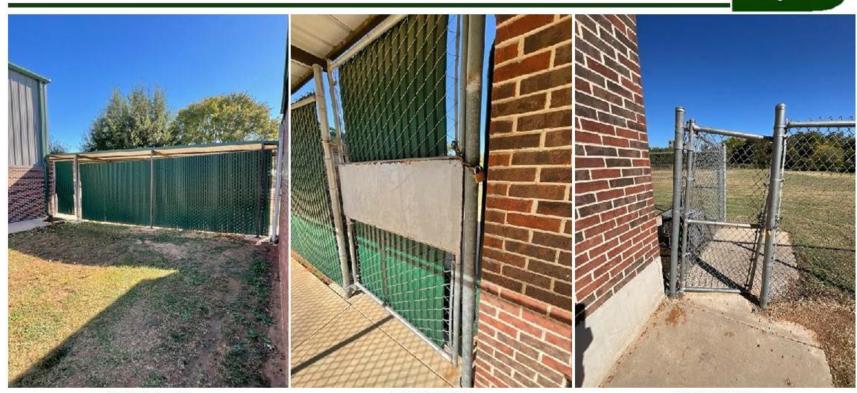
SECURITY RISK SECURITY RISK SECURITY RISK

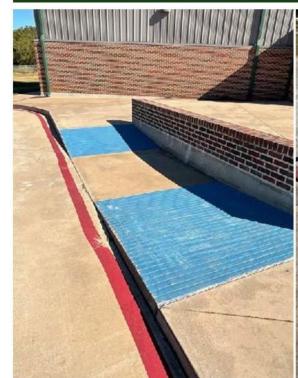
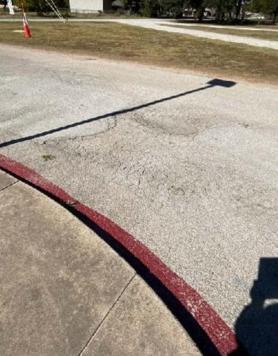
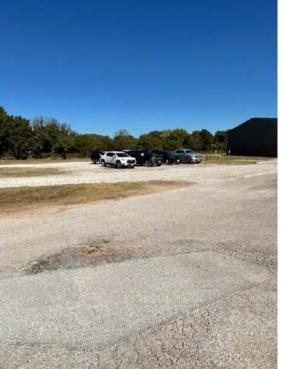
DETERIORATING PARKING/STRIPING

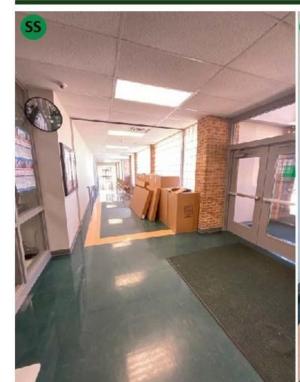
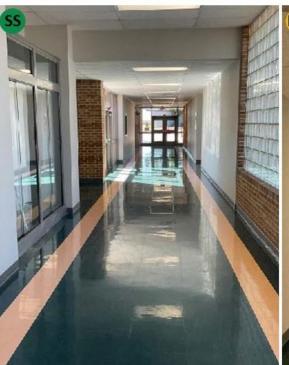
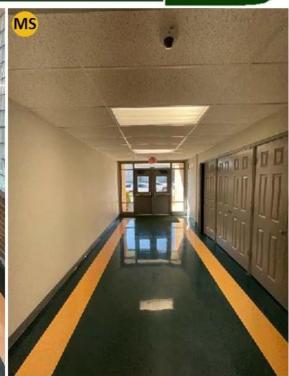
NEEDS SECURE VESTIBULE

- Secure and isolate the locker rooms above the gymnasium that have potential asbestos
- Modify both entrances to create a secure vestibule and restrict public access to the shared library

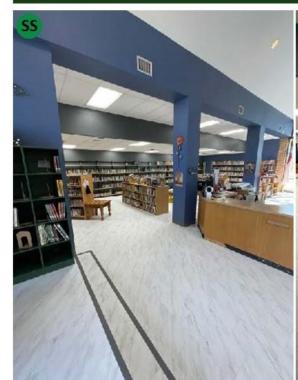
DOES NOT MEET TAS/ADA

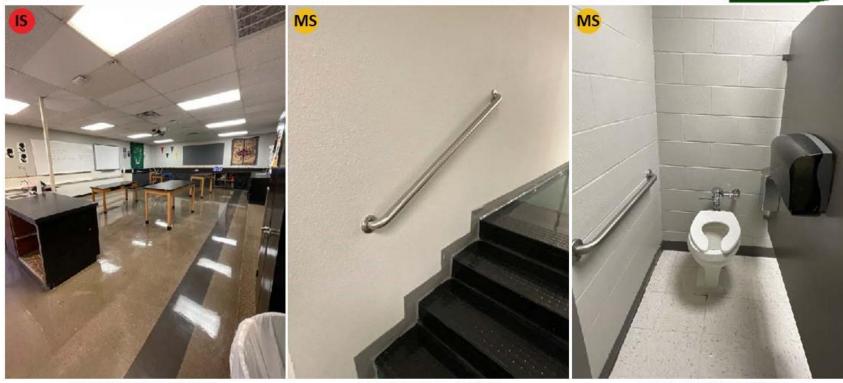
DOES NOT MEET TAS/ADA

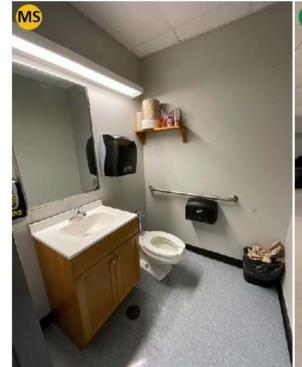
DOES NOT MEET TAS/ADA

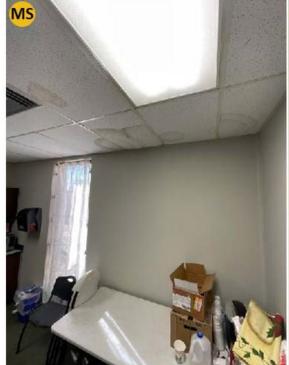
EVIDENCE OF MOISTURE DAMAGE

- Reroute storm water from roof drains away from the building near the gymnasium
- Repair roof leaks and address clogged condensate lines
- Replace any water damage ceiling tiles due to stormwater or leaks from a condensate line or plumbing

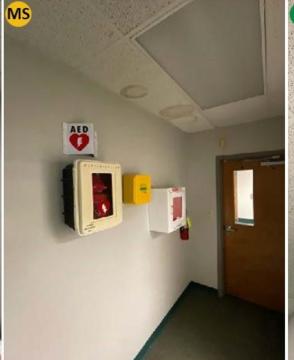
EVIDENCE OF MOISTURE DAMAGE

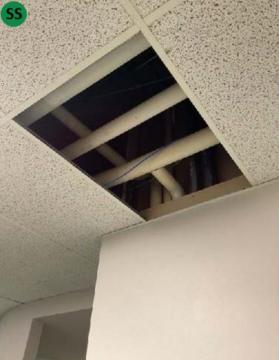
MISSING CEILING TILE

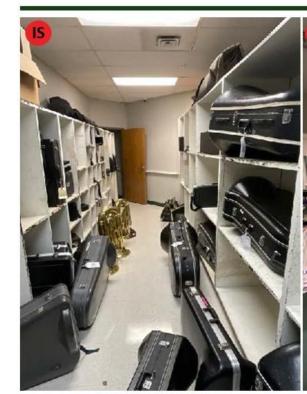
INADEQUATE STORAGE

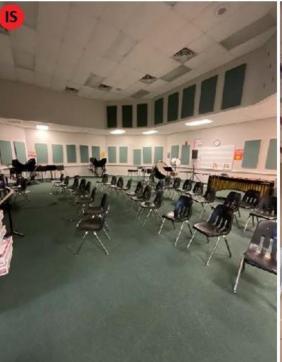
INADEQUATE LIGHTING

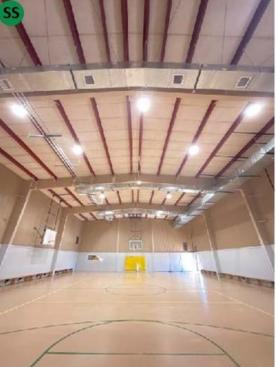
GYM AGING RAPIDLY

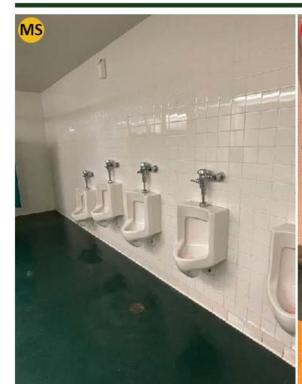
NEED HDPE DIVIDERS

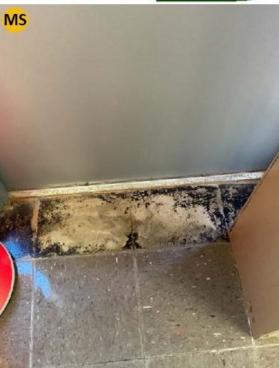
INADEQUATE ELECTRICAL

DETERIORATING FLOOR

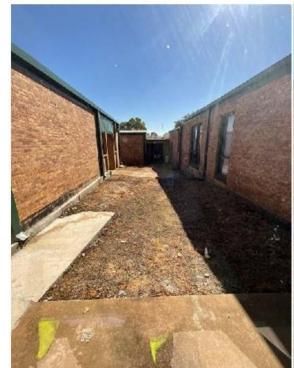
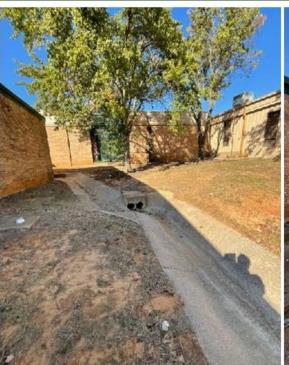
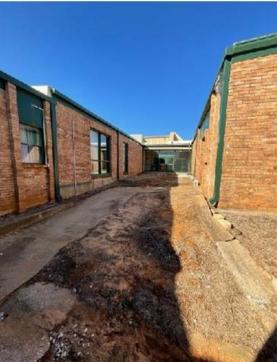
INADEQUATE DRAINAGE

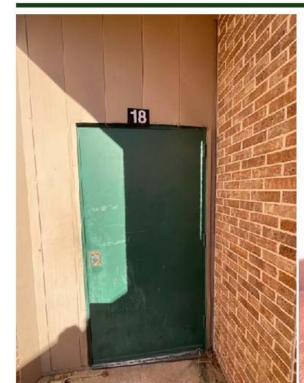
INADEQUATE HARDWARE

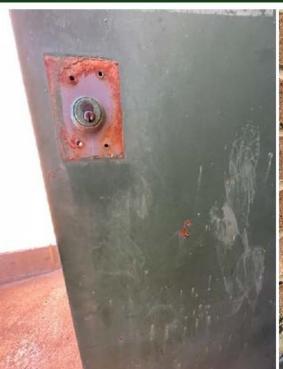
INADEQUATE HARDWARE

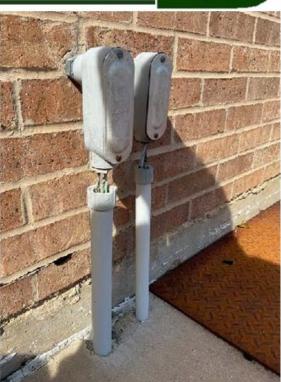
INADEQUATE ELECTRICAL

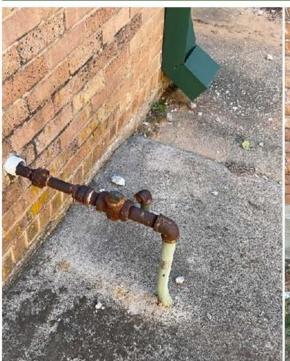
SAFETY RISK / GAS LINE NEEDS REPAINTED

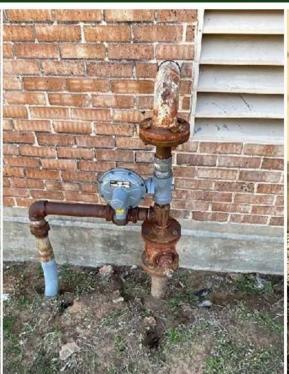
SAFETY RISK / UTILITY LINES NEED REPAINTED

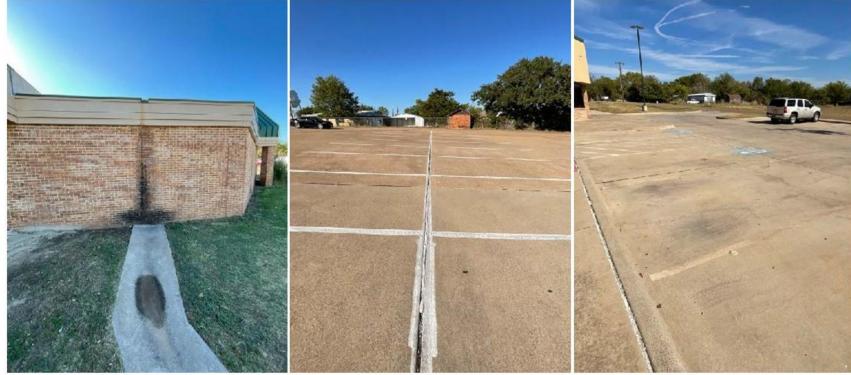
MOLD / MILDEW PAVEMENT STRIPING FADING NEEDS RESTRIPING

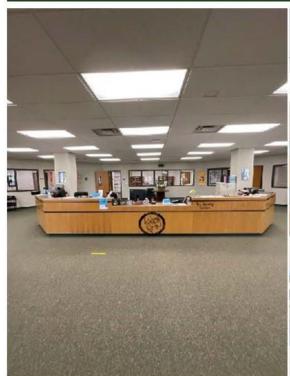
DOES NOT MEET TAS/ADA

MEETS TAS/ADA

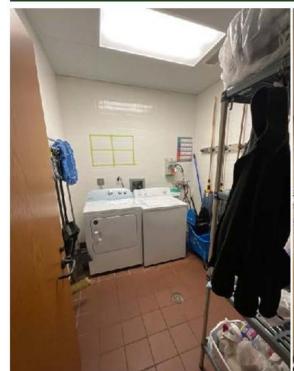
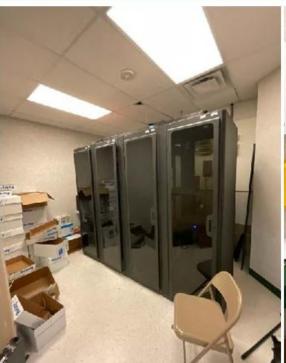
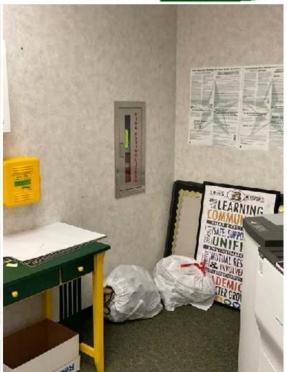
INADEQUATE STORAGE

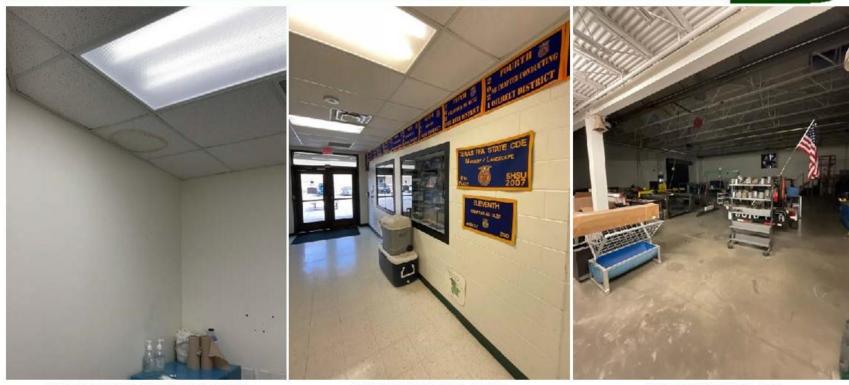
NEEDS SECURE VESTIBULE

INADEQUATE LIGHTING

- Install film over glass along corridors near the front entrance to increase security and reduce exposure
- Install commercial-grade splash guards near downspouts to reduce soil erosion

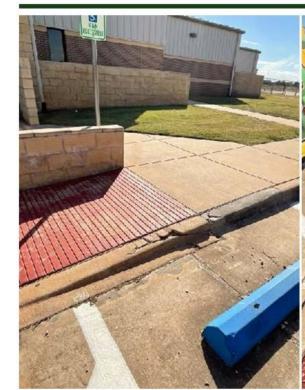
ADA RAMPS NEEDS REPAINTING

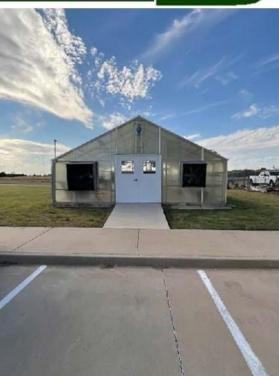
DOES NOT MEET TAS/ADA

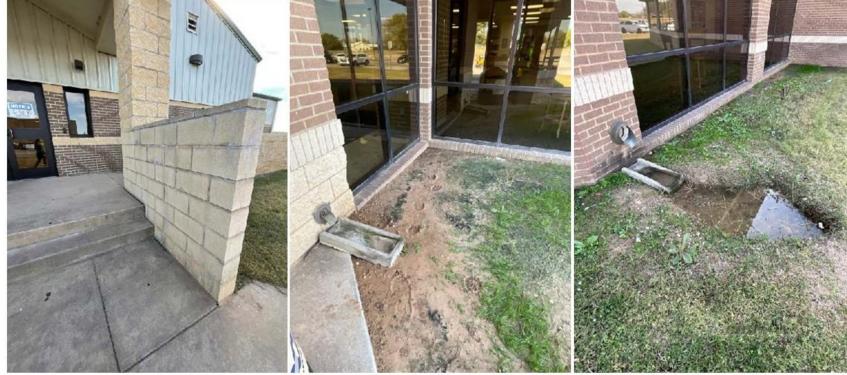
HANDRAIL MISSING / SAFETY RISK

INADEQUATE DRAINAGE

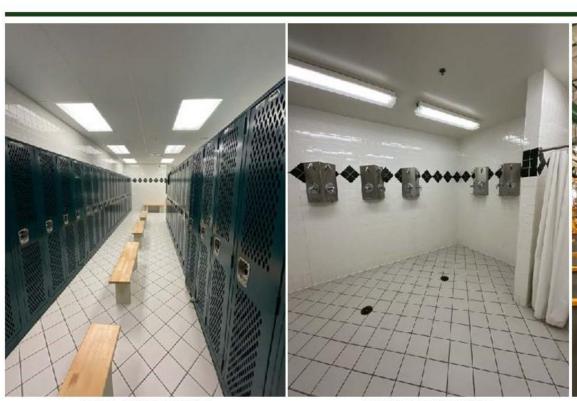
EXPAND WEIGHT ROOM

- Locker rooms are undersized and do not meet current TEA requirements
- Restrooms need to be upgraded to meet current TAS/ADA requirements
- Toilets do not meet current TAS/ADA requirements
- Relocate the light switch inside one restroom located inside a toilet area and behind the partition wall.
- Expand the floor area of the weight room to accommodate the equipment and allow more space

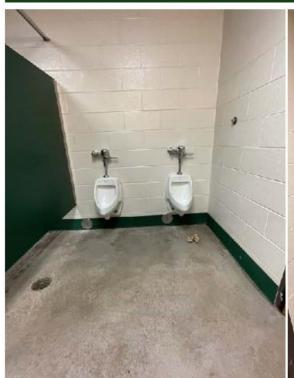
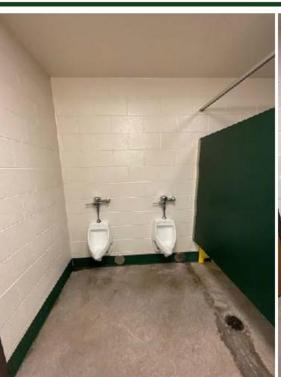
NEED HDPE PARTITIONS

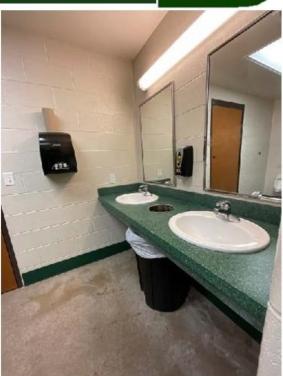
DOES NOT MEET TAS/ADA
