DISTINCTIVE LEARNERS EXCEPTIONAL LEADERS

FACILITY ASSESSMENT

BOYD ELEMENTARY SCHOOL

BOYD INTERMEDIATE/MIDDLE

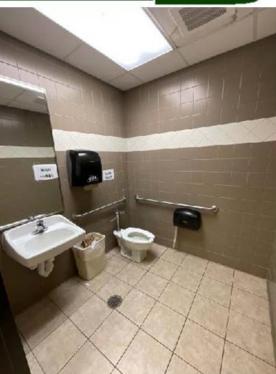
DOES NOT MEET TAS/ADA

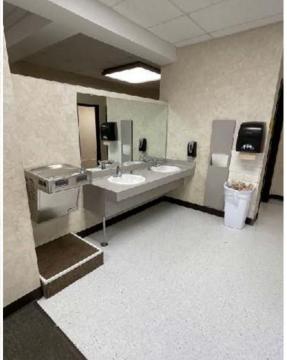
DOES NOT MEET TAS/ADA

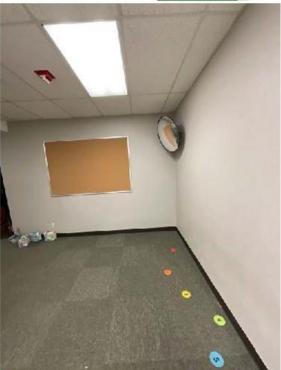
UNDERSIZED CLASSROOM

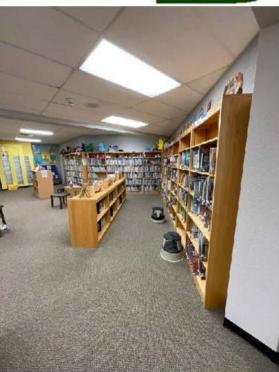
UNDERSIZED LIBRARY

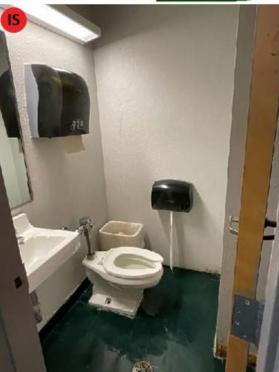
DOES NOT MEET TAS/ADA

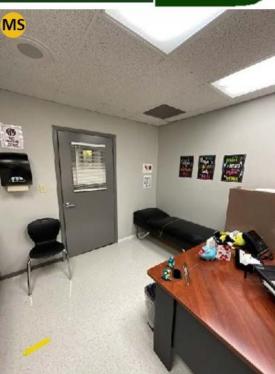
DOES NOT MEET TAS/ADA

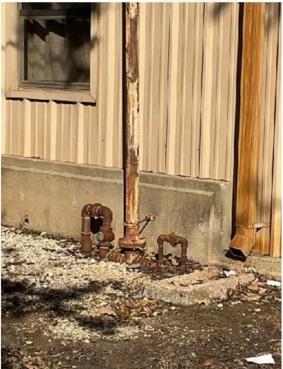
SAFETY RISK / GAS LINE NEEDS REPAINTED

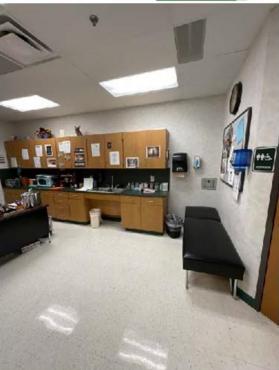
DOES NOT MEET TAS/ADA
